# THERMOGRAPHY 101 – A SHORT PRIMER

By Daniel S. Amster

August 2011

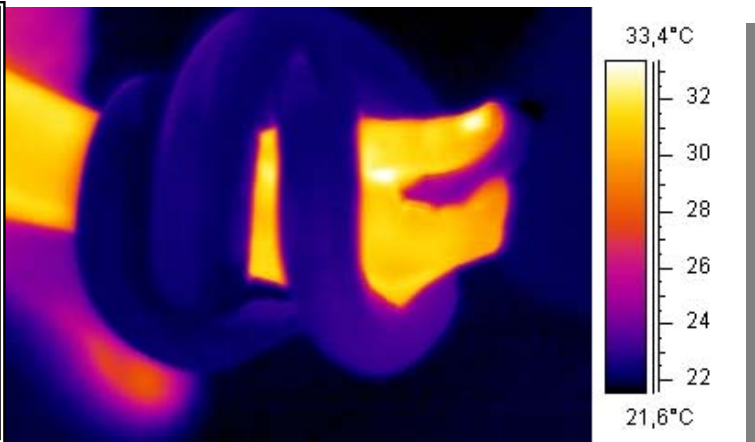
*The thermographic image on the right is a person holding a snake. The person is radiating heat at approximately 98.6 °F (37°C) while the snake (as a cold blooded animal) is the same temperature as its surroundings and therefore radiates almost no heat. The person's arm appears bright yellow in the picture (hot) while the snake appears dark purple (cool, it's almost the same color as the background).*

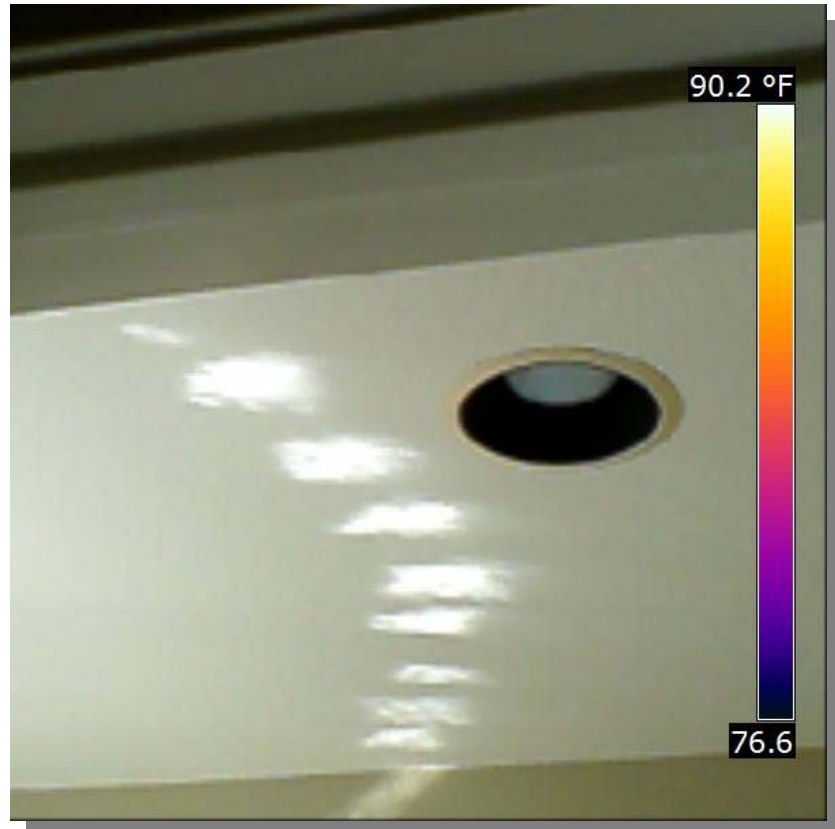
*Visible light photograph of a ceiling and a recessed light fixture. Everything looks normal enough, but this ceiling was damaged by a water leak. The extent of the damage is not visible to the naked eye...*

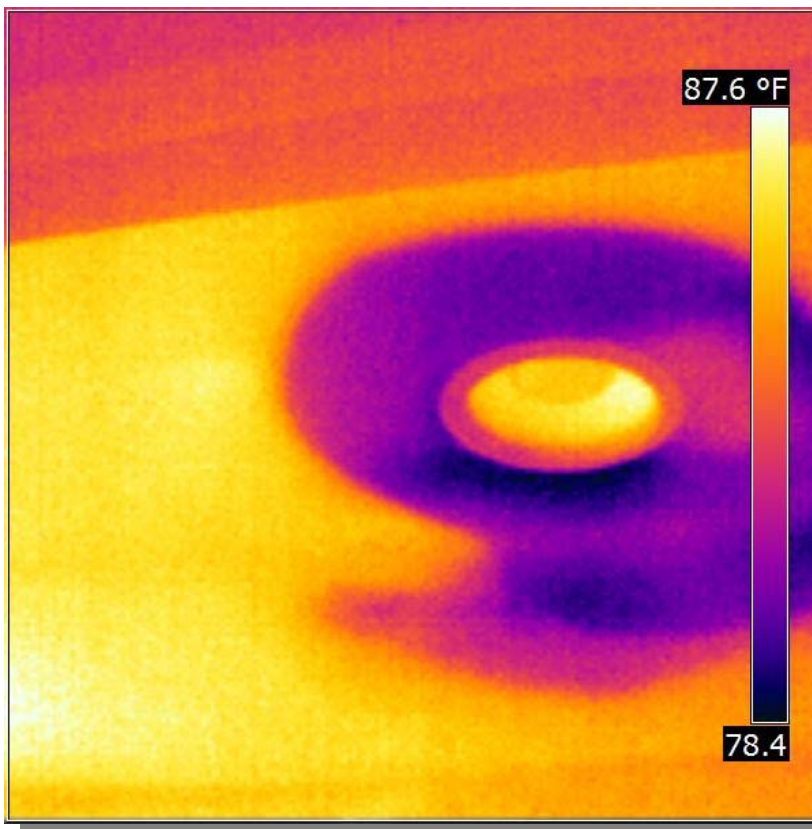
*... but you can't hide the heat signature... On the left is a thermographic image of the same light fixture as above. The extent of the water damage is clearly shown around the fixture. Varying shades of blue/purple indicate the extent of the water damage; the darker purple, the more water intrusion.*

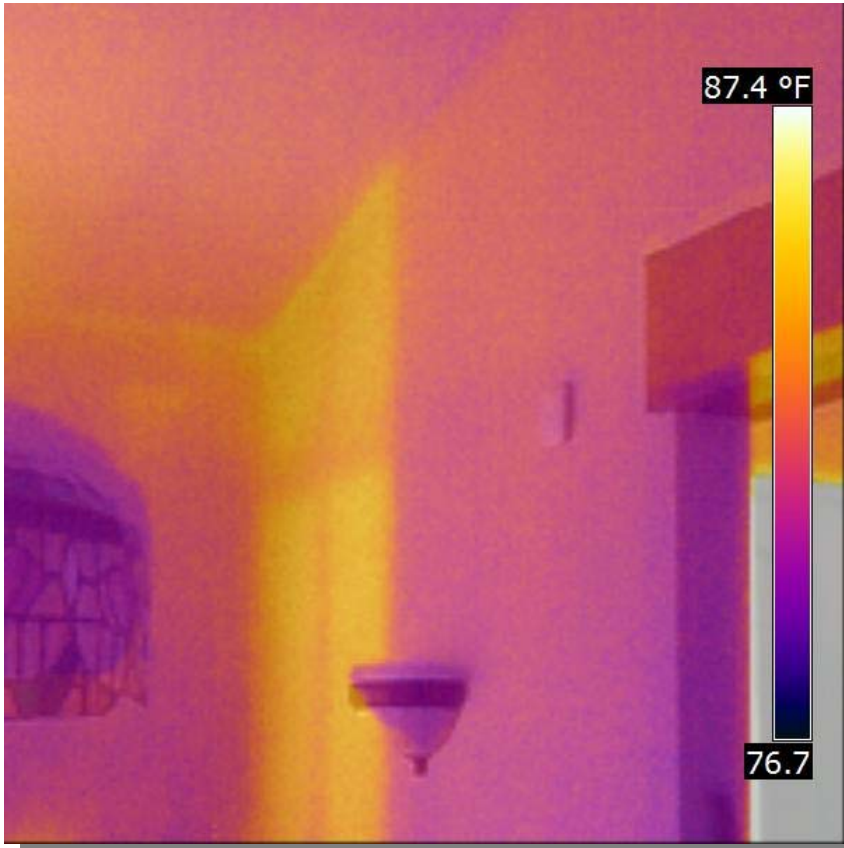
The thermographic image on the left was taken as part of an energy audit of a custom built private residence in Las Vegas. The bright yellow section of wall (center) is a sheerwall that appears to have no insulation. During construction the plywood sheathing was obviously applied before the insulation was installed (a fairly typical problem). When the rest of the house was insulated, this area was covered over, not visible and therefore it was not insulated. Note the sharp contrast between the areas that were insulated and those that are not. This house had many areas of missing insulation.

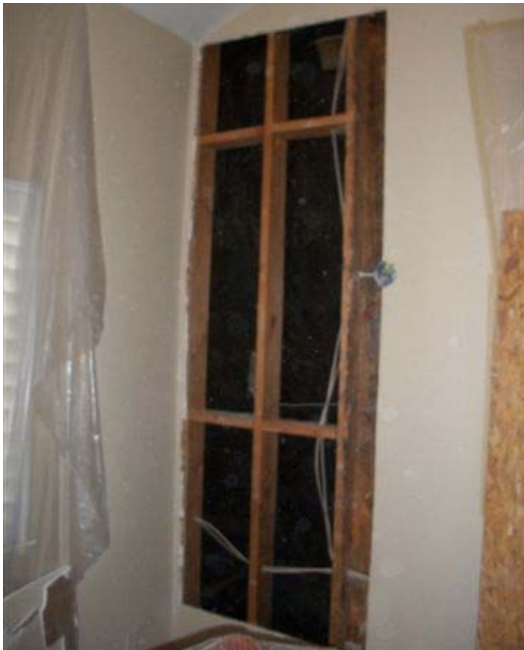
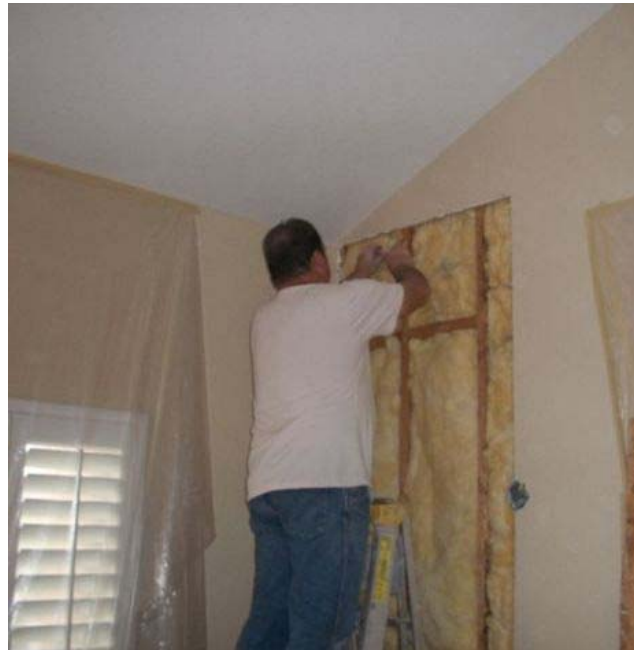
Repairs entailed removing the drywall and the sheerwall panels to expose the un-insulated wall cavity (seen on the left). New insulation was installed (right); the sheerwall panels and drywall were then replaced and finished to match. In this particular residence approximately 20% of the ceilings were not insulated as well as a 320 s.f. section of west-facing exterior wall. Once these problems were corrected, the home owner reports more comfortable living and lower energy bills to match.

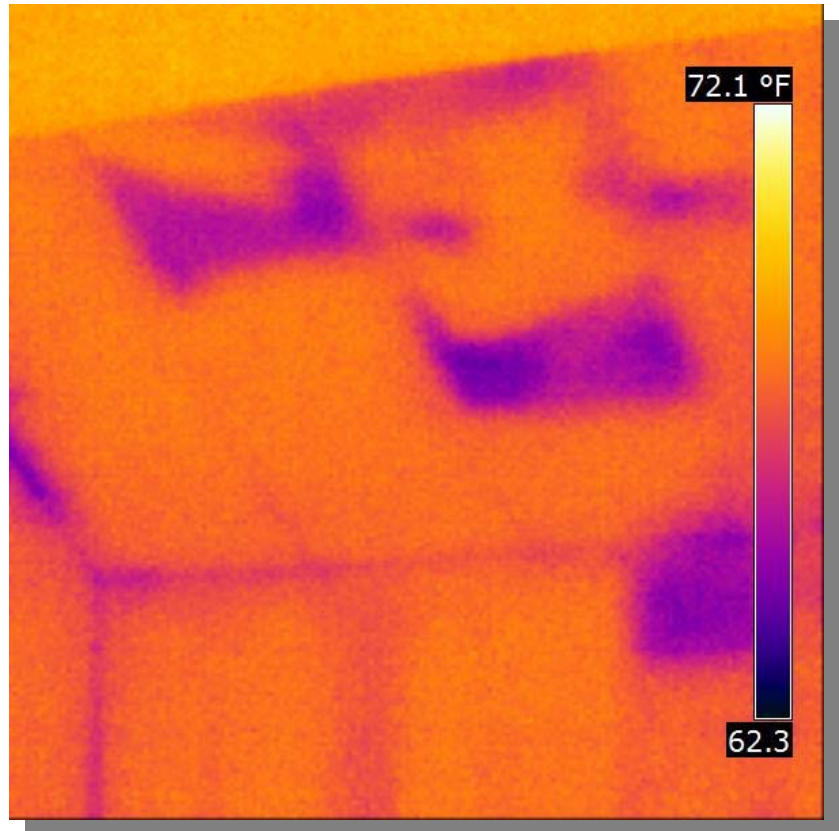
The thermographic image on the right shows areas of exterior walls and a vaulted ceiling that are missing insulation (visible as purple in this image). The wood framing also shows up as purple, indicating that it is not as good an insulator as the fiberglass insulation. Repairs to these areas include removing the drywall, installing new insulation and replacing the drywall.

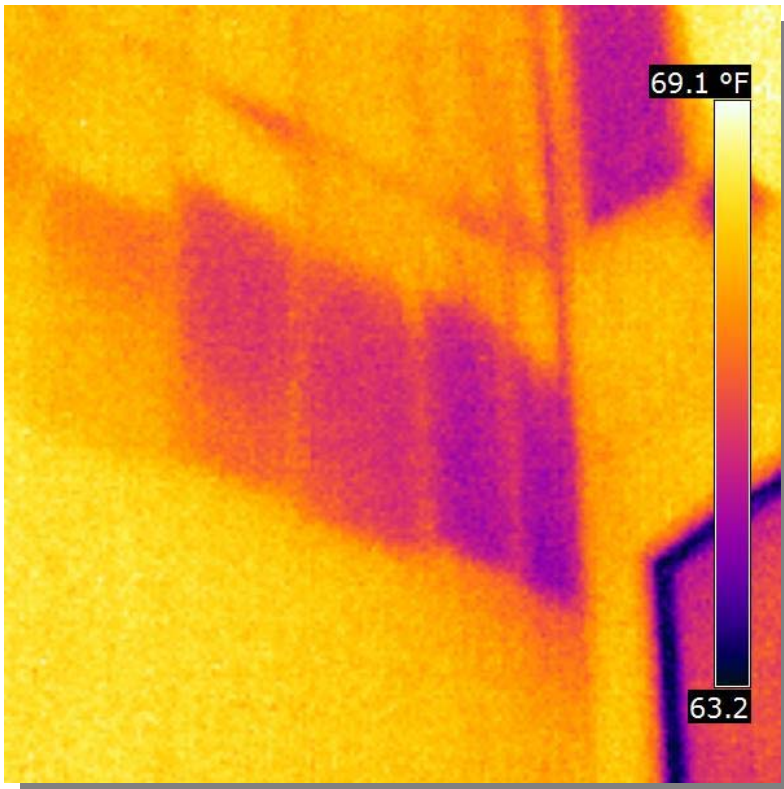
The thermographic image on the left shows areas of exterior walls that are simply missing insulation despite being in plain sight when the insulators were onsite. Perhaps the wind blew the insulation out of the wall before the drywall was installed? The dark area (bottom right) is actually artwork hanging on the wall.

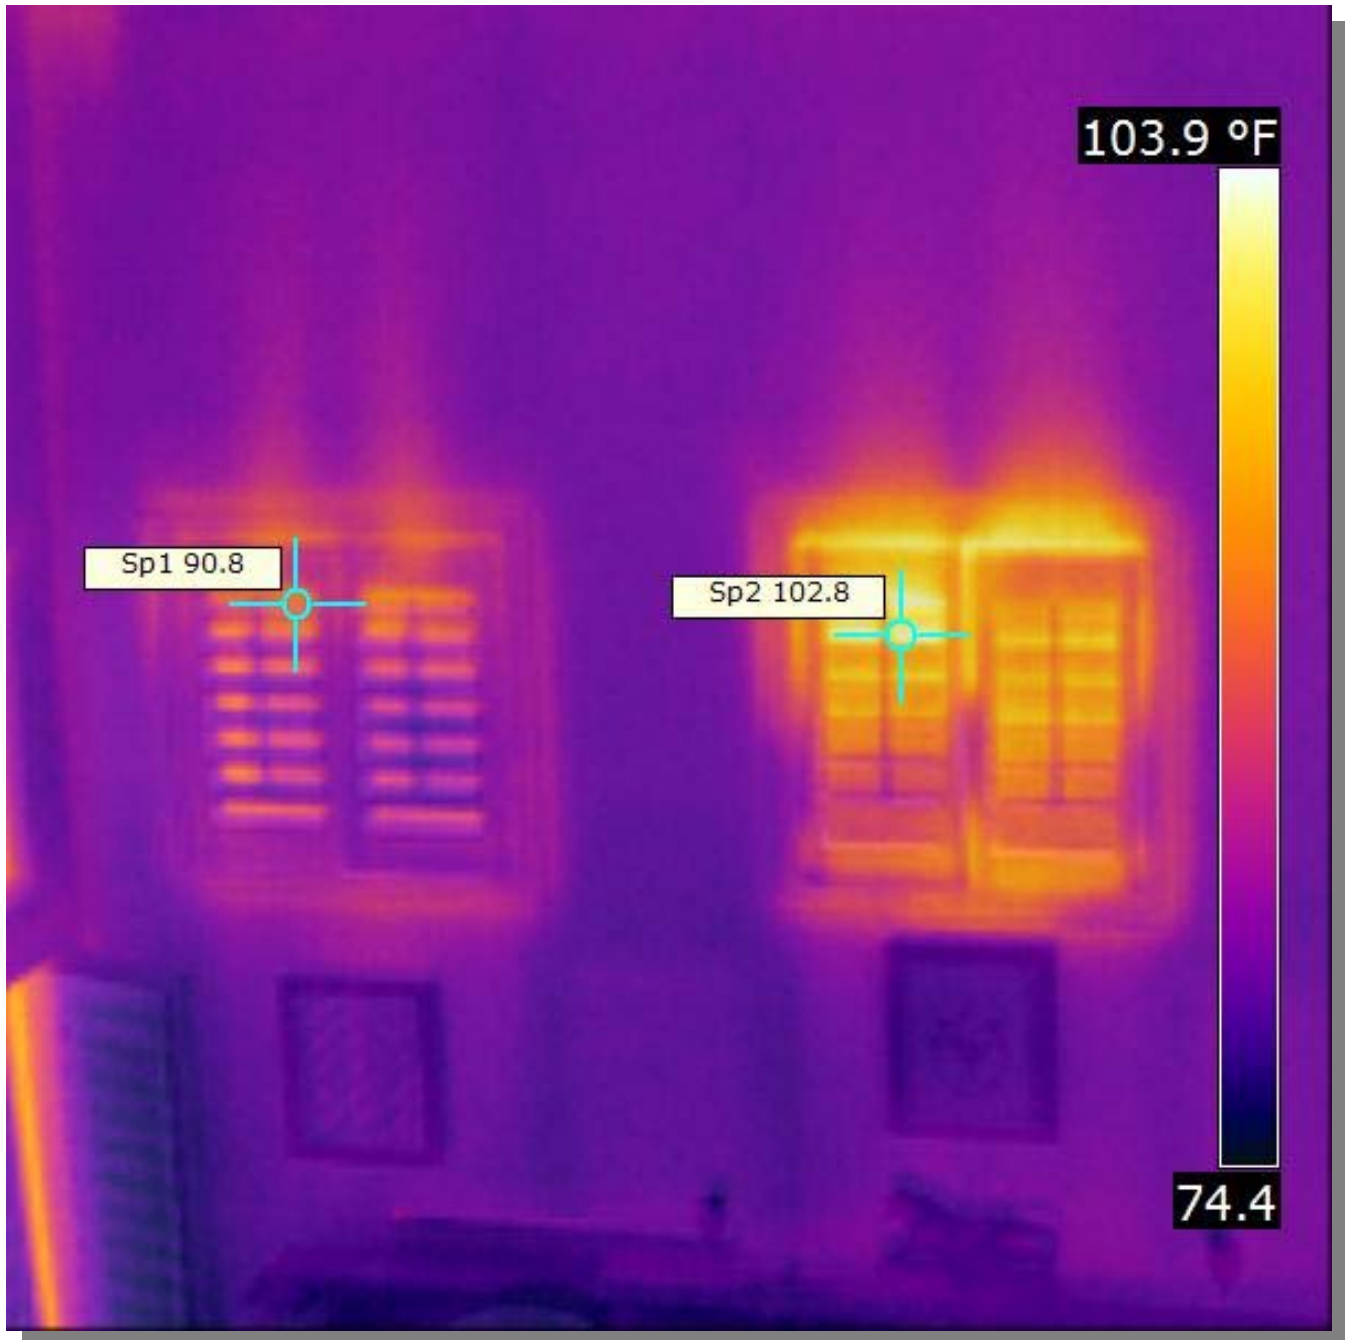
*Got sun? The thermal image above shows the impact of low emissivity (commonly called low-e) window tint. The two windows shown have full sun exposure and are identical except that the window on the left has a low-e film applied. Due to the nature of emissivity the temperatures shown may not be accurate; what is important is that the low-e film reduces the temperature of the left window 12°F compared to the window on the right.*

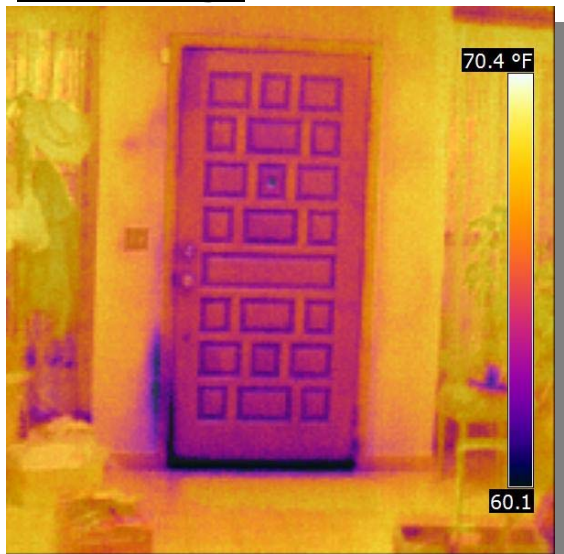
#### Top photo

*Air leakage seen as dark purple under a front door. Insulation also appears to be inadequate in the wall to the lower left of the door.*

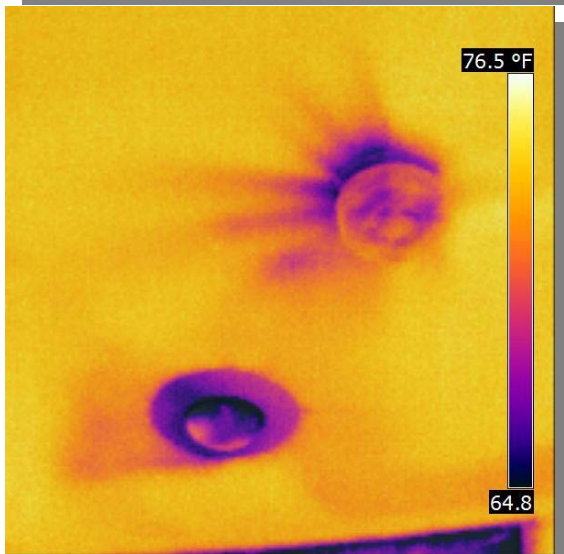
#### Middle photo

*Air leakage around a smoke detector and recessed can light visible as dark purple on the ceiling.*

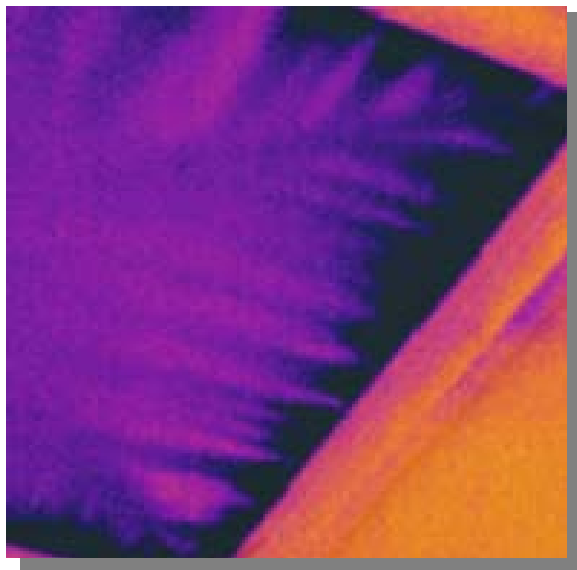
#### Bottom photo

*Air leakage of an un-insulated attic access door seen as dark purple in this thermographic image.*

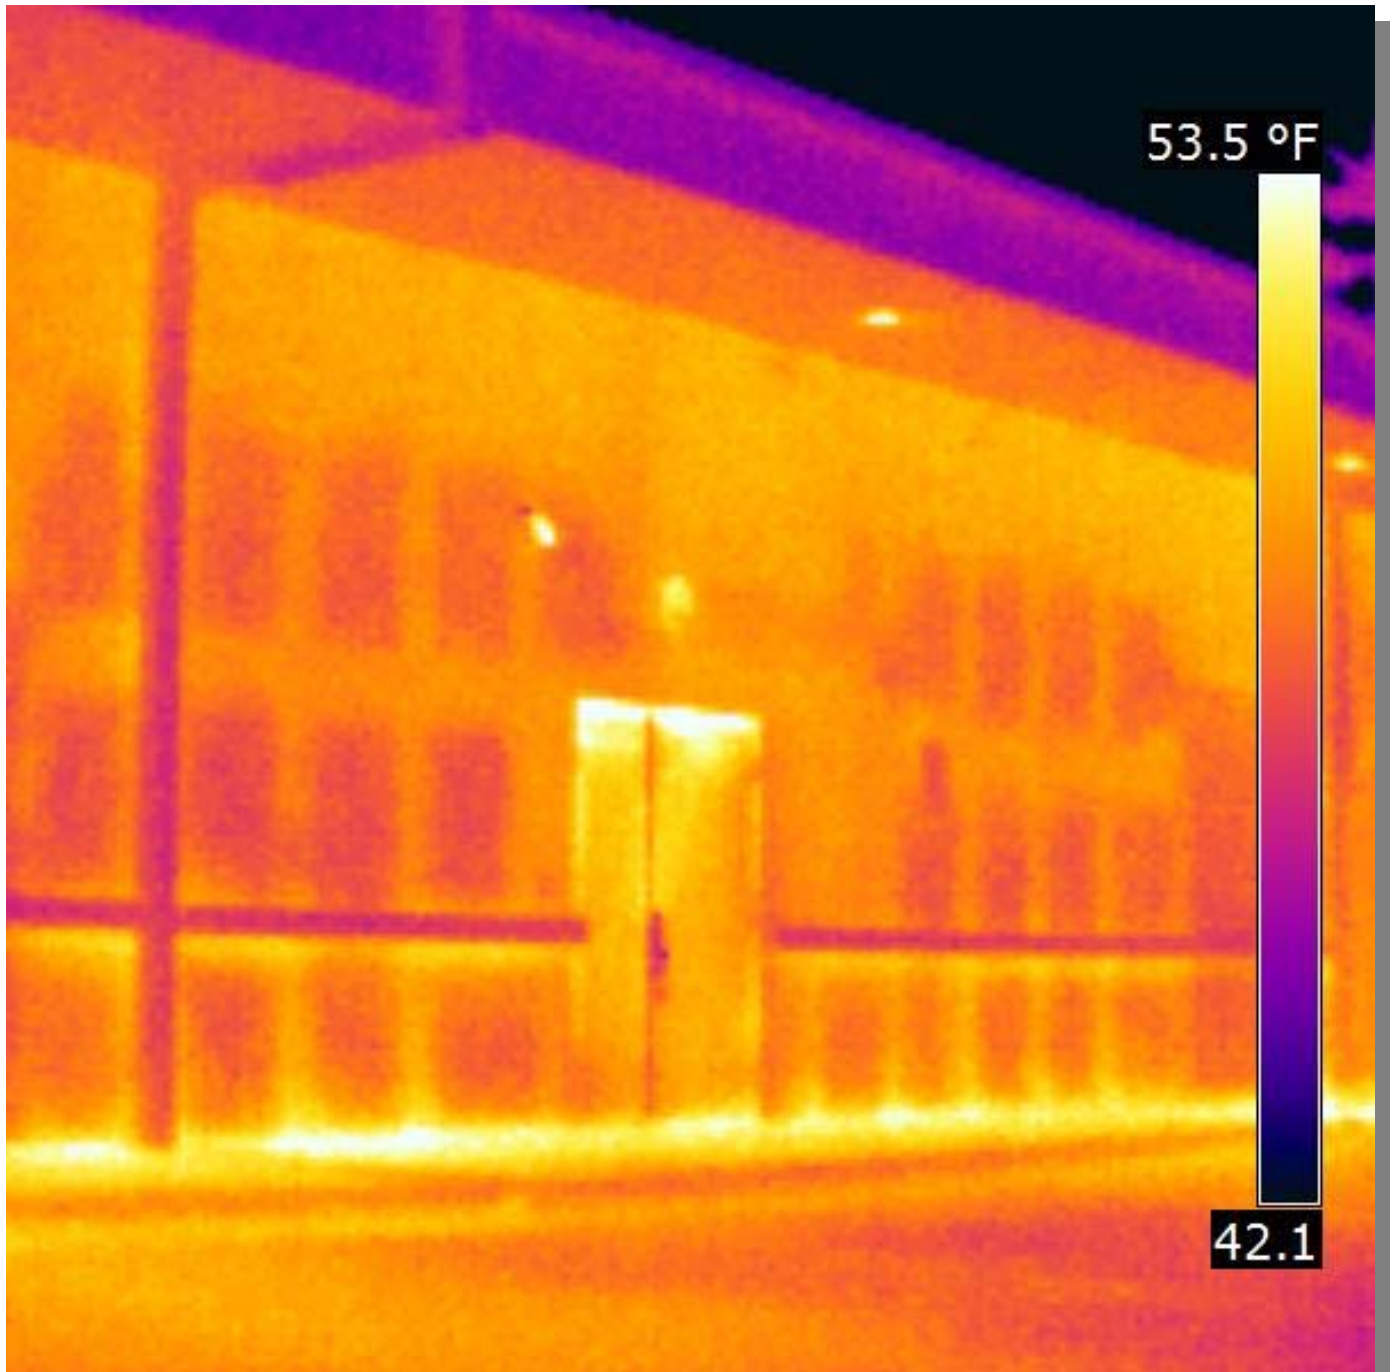
*On a recent project, the client needed to analyze an existing masonry structure. The tried and true method is to walk along the wall tapping with a hammer listening for differences in the sound. Using a thermographic image yields more accurate results in a fraction of the time. The lighter shaded areas are grouted solid and contain reinforcing steel – exactly what the client needed to know.*

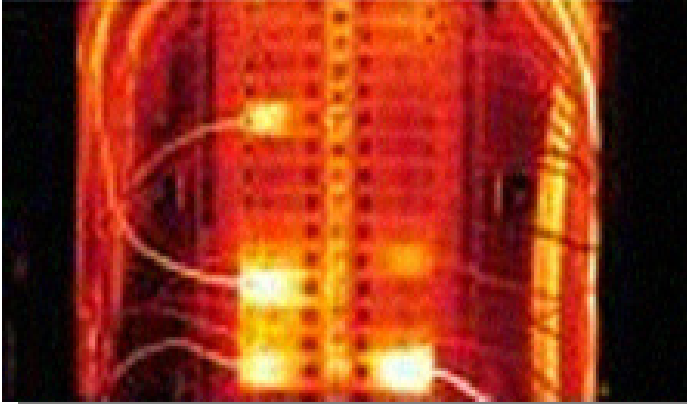
*As electrical components age and wear they draw increasingly larger electrical loads and heat up, further stressing the components. This is an example of a progressive failure.*

*Building electrical services and switchboards can be thermographically imaged without interrupting electrical service to any occupants. In the thermographic image (top left) circuit breakers drawing large loads are shown as bright yellow.*

*In the thermographic image (bottom left) the fuse on the far right is carrying more load and is therefore much hotter than the other two and appears almost white. Catastrophic failure can be averted with timely maintenance by a competent electrician.*

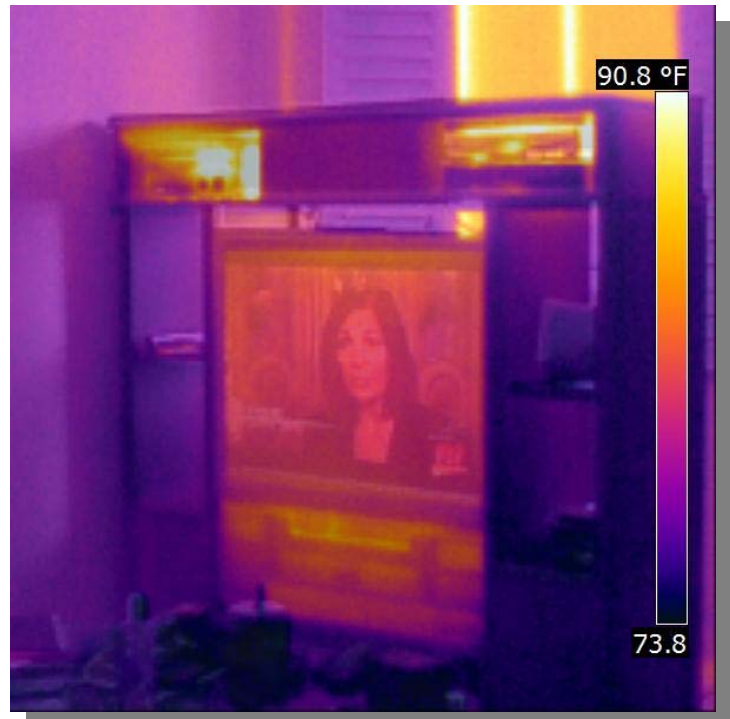
*Some electrical items like printers, photocopiers, and DVRs consume significant amounts of electricity while they sit idle; some 24/7. In the thermograph (right) a DVR and a cable box are seen bright yellow indicating significant phantom power consumption.*

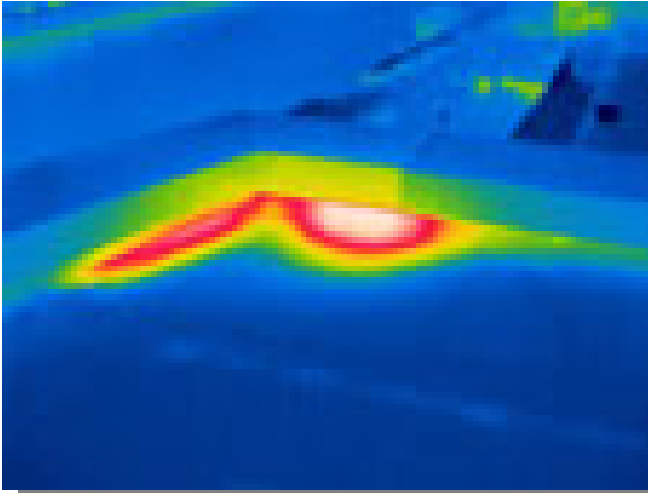
*In the thermographic image (left) water trapped under the roof membrane appears white – warmer than the surrounding roof membrane and insulation. In the image the parapet coping has a seam immediately above the wettest (warmest) part of the affected area and this is the likely source of the leak.*

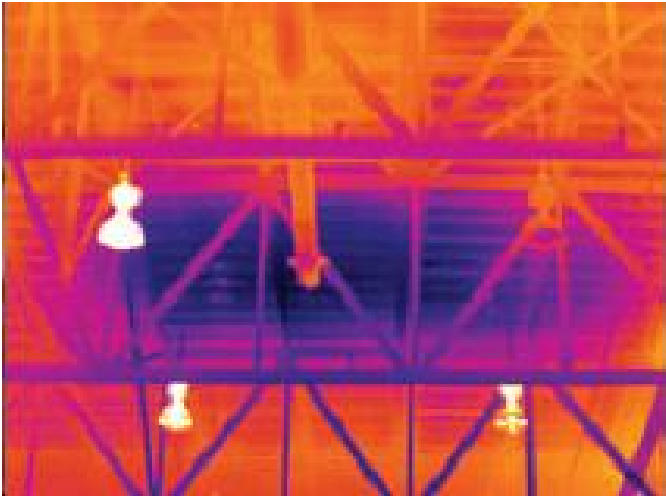
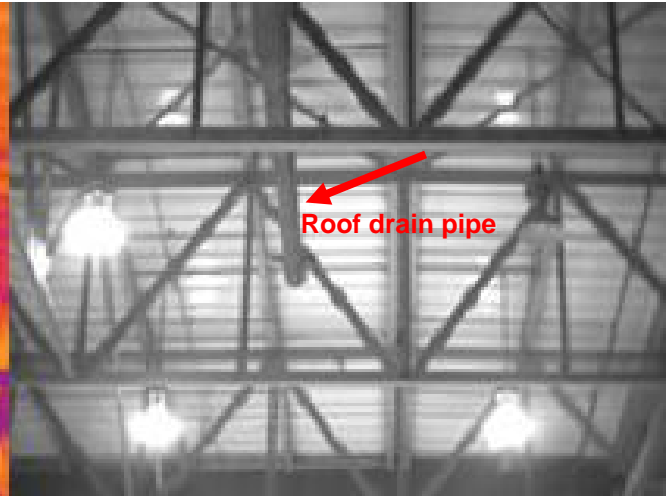
*In the thermal image (below left) there is an area of relatively cooler temperature in the center. In the photograph (below right, the same view) a roof drain pipe is visible, indicated by the red arrow. Roof drains are a common source of roof leaks.*

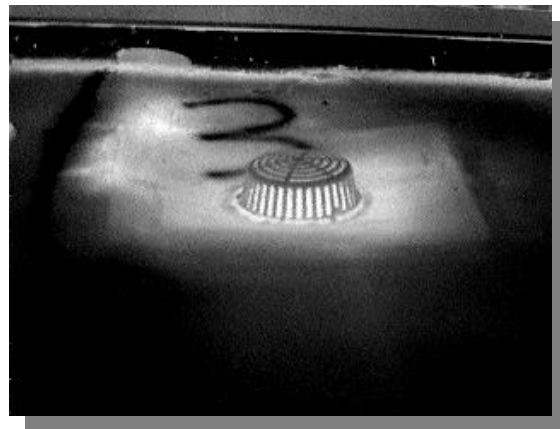
*The black and white thermographic image (right) is an example of what a leaky roof drain would look like from above the roof. Leaks found without guesswork of removing the existing roof.*
